# Sinking of the Deepwater Horizon

11 perish and 115 survive

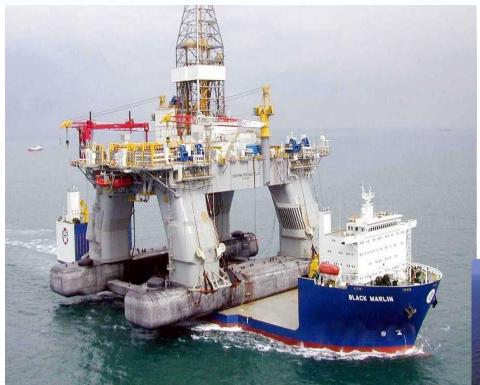
Nautilus, being transported on a Heavy-Lift vessel

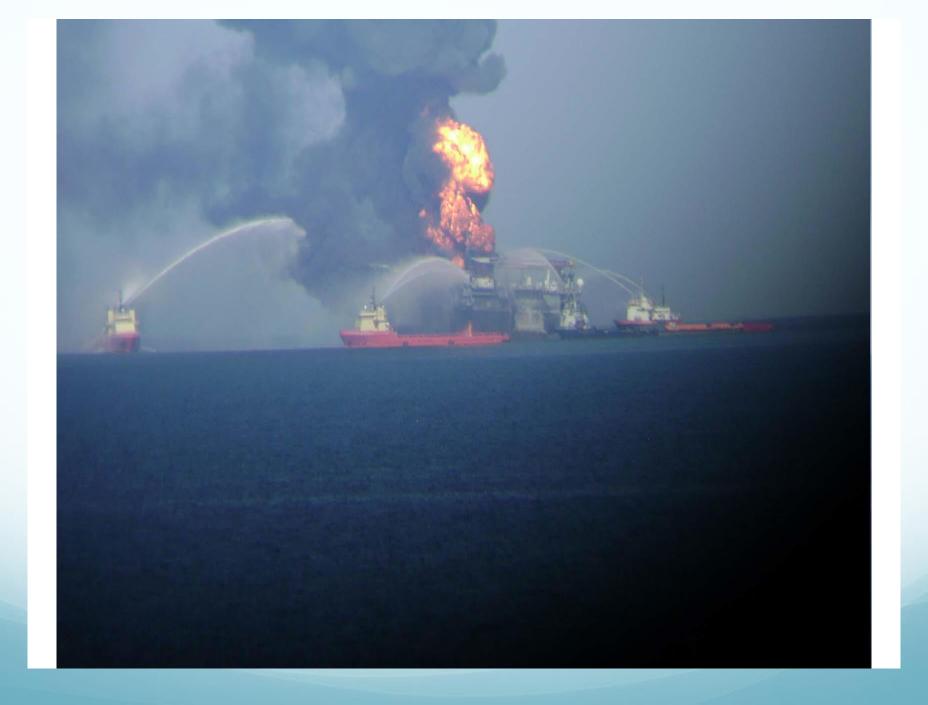
Early morning Day 2 – Note the hole burned through the aluminum helideck

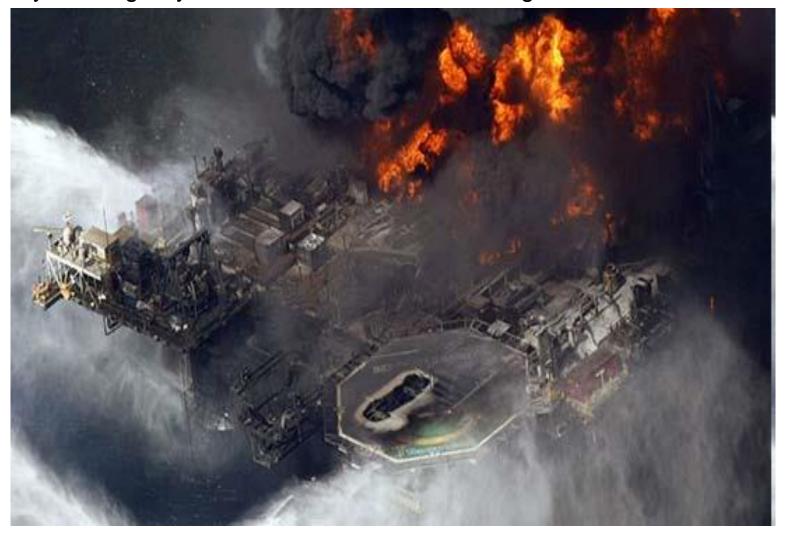
Day 2, morning – settling quite low in the water now – fuel and oil slick forming

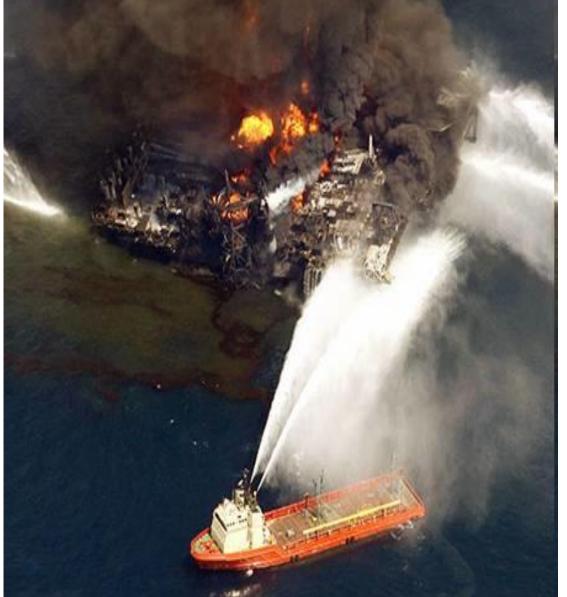
Support vessels using their fire fighting gear to cool the rig – note the list developing

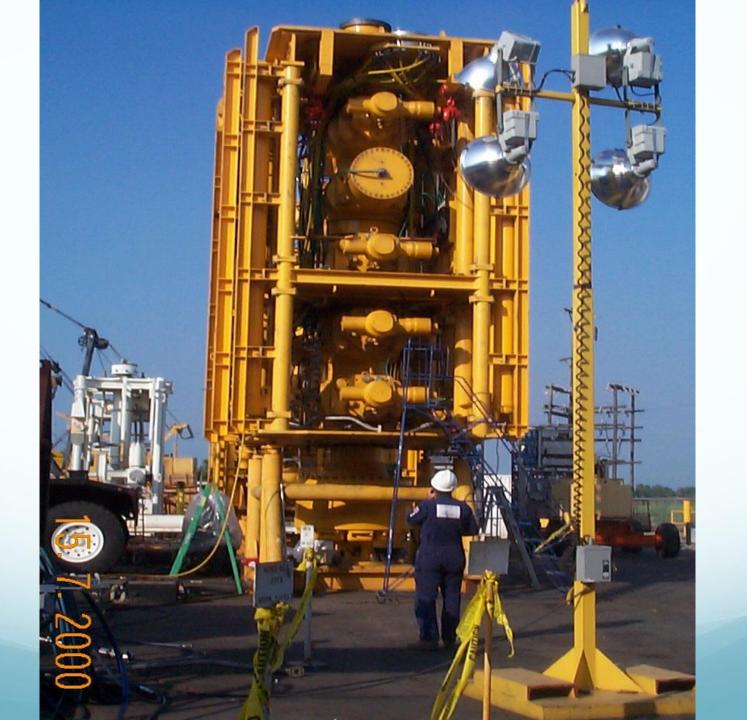
- The BOP functioned and closed but was overcome by well conditions
  - High flow from the well prevented the annular BOP element from sealing
  - The concentrated flow eroded the drill pipe above annular
  - VBRs isolated the annular space temporarily until pressure increased in the drill pipe and ruptured it allowing hydrocarbons to flow to the riser
  - When the DWH drifted off location the drill pipe parted
