# Hydrogen Safety – Best Practices, Codes, and Standards

**Presented to EAPUOC**

**Fire Protection Engineer**

**Strathcona County Emergency Services**

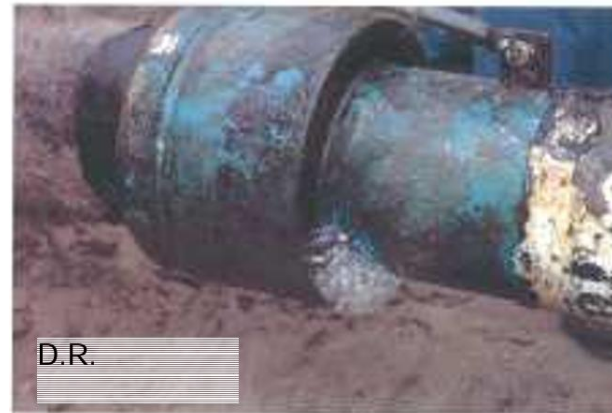
- A pipeline, transporting pressurized hydrogen gas (75 bar, 6 inch, steel) from Antwerp (Belgium) to Rotterdam (the Netherlands). The leakage occurred at a location at which the pipeline entered a building and contained a “CP coupling” (a device to interrupt the cathodic protection).

- An underground hydrogen gas pipeline developed a leak
- Possibly discovery was after weeks/months of leakage
- Lasted for at least several hours
- Occurred at a specific “weak spot” ... partial failure of a so-called “CP Coupling”
- ignited by welding activities on another pipeline in the corridor. The ignition resulted in a small fire on top of the soil covering several existing pipelines transporting several types of gases.
- As a precaution, residents of the village nearby were advised to stay indoors for about three hours. Busy traffic on a nearby waterway to and from the Rotterdam harbour area was halted for several hours. After the conclusion that it was a hydrogen release and fire restrictions were lifted.

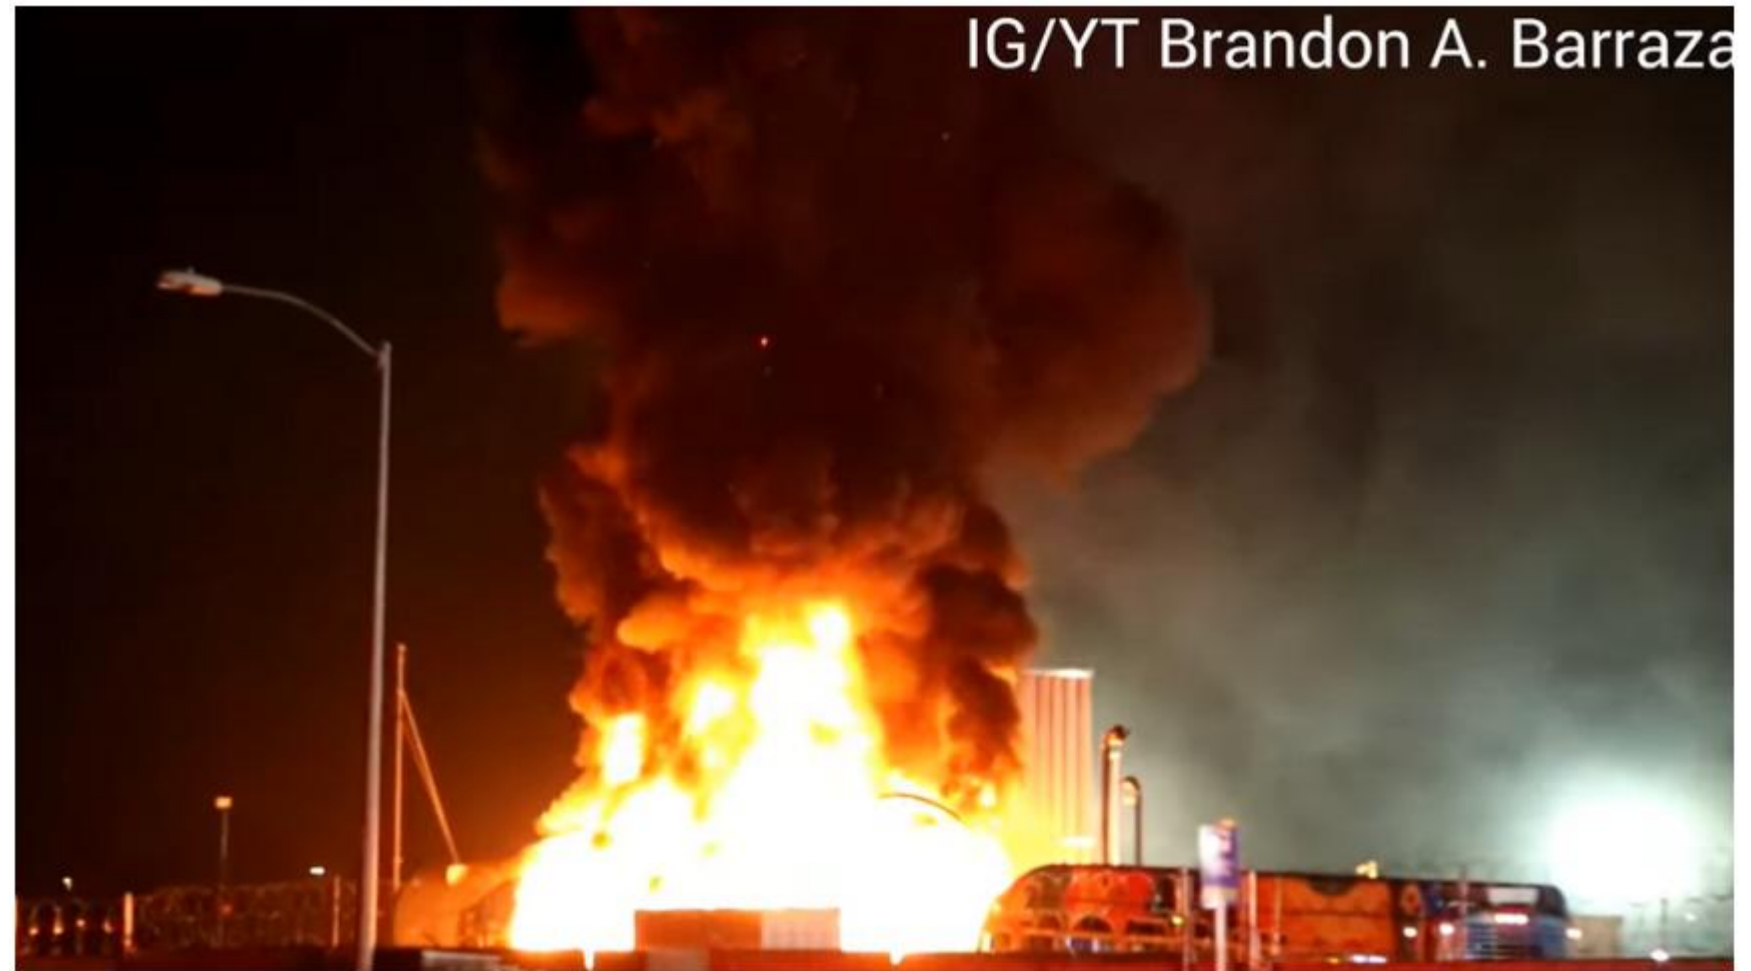
*A GET hydrogen bus, valued at \$1.1 million, was destroyed and part of the fueling station was damaged during an early morning fire on Golden State Highway. PHOTO: Brandon*

- The hydrogen buses were being fueled at the time of the fire.
- According to the release, one bus was destroyed and only the dispensing portion of the hydrogen fueling station was damaged.
- Explosions were heard and seen from the tanks on the bus that had just been filled, but the primary tanks of the actual fueling station did not ignite due to safety technology.
- The state-of-the-art fueling station opened up just seven months ago.
- Since it's the only hydrogen fueling station in town, Sanders said there will be delays.
- *"Because we are the only hydrogen fueling station in Kern County, we won't be able to fuel our 10 hydrogen buses, so it could possibly cause some delays on our service because there will be ten buses out of service because we aren't able to fuel them."*

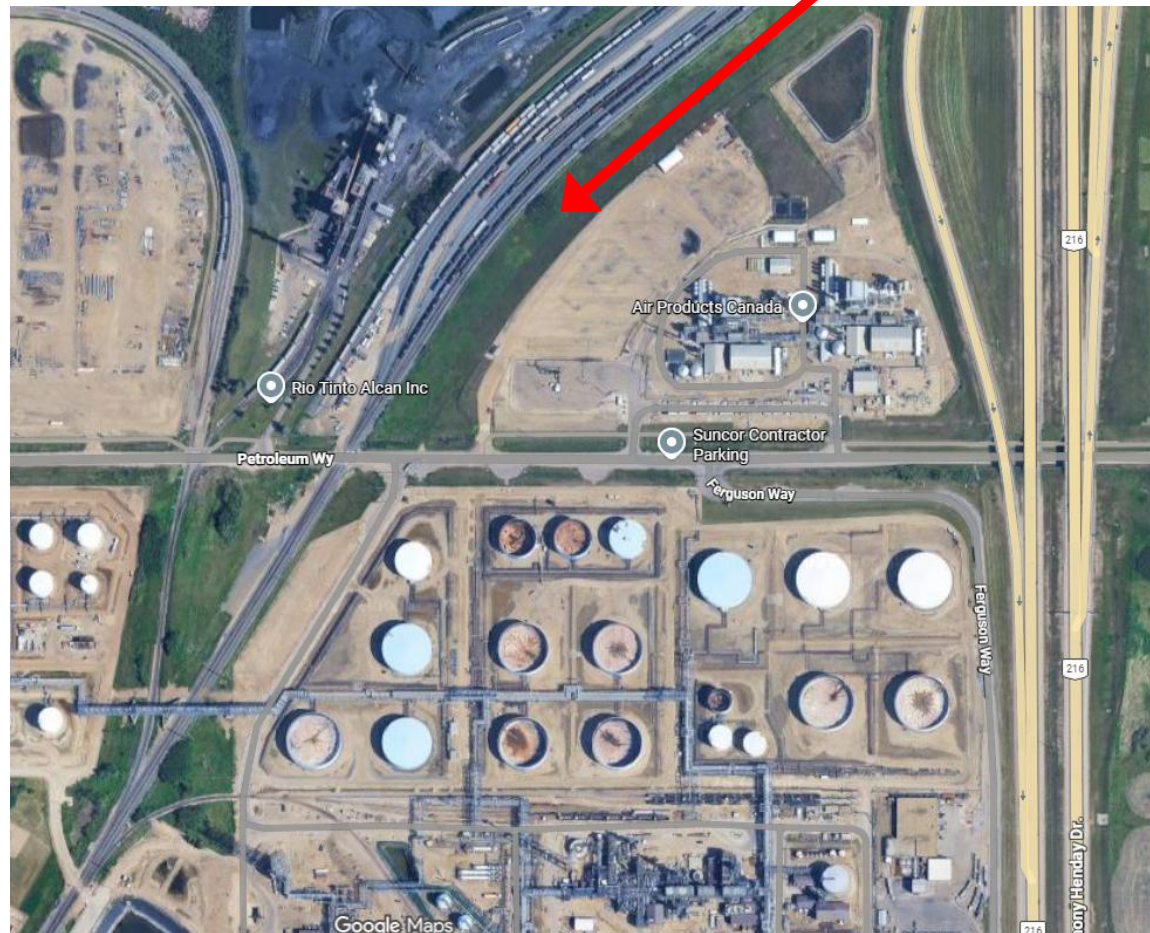
- Facility features a 1-megawatt (MW) electrolyzer, compressor, storage, and dispensing systems designed specifically for locomotive refuelling.

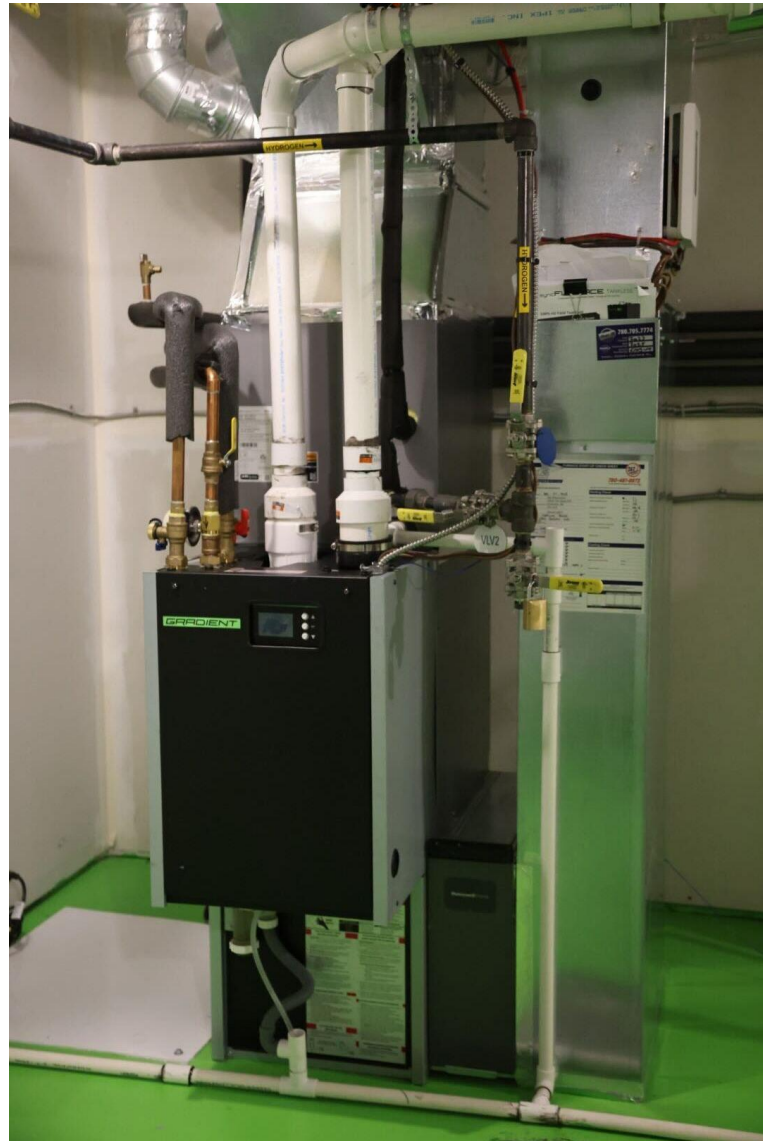
# H2 House

- Hydrogen Furnace in mechanical room with SIL 2 hydrogen detection and shutoff valve
- Mechanical Room closes automatically.
- HVAC of Mechanical Room is separate from HVAC of rest of the house
- Pressures Trailer: 2995L@3625 psig, supply line 80 psi, house 0.25 psi.
